Building Number: 23

Original Name: Dormitory / BOQ

Est. Year of Construction: 1952

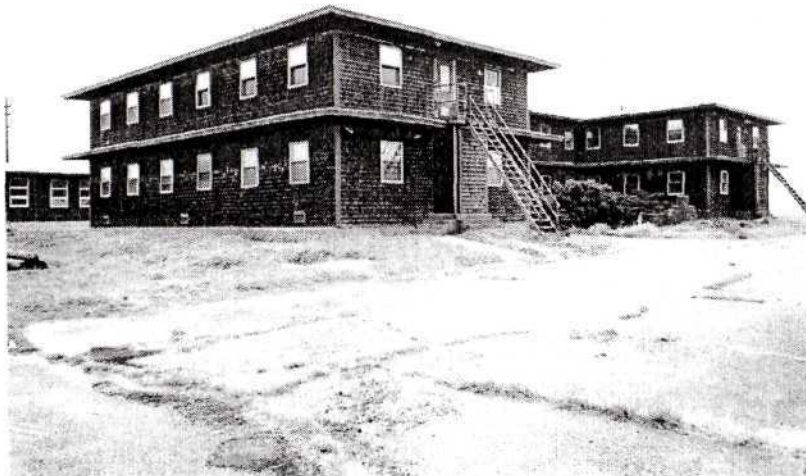
View from southwest.

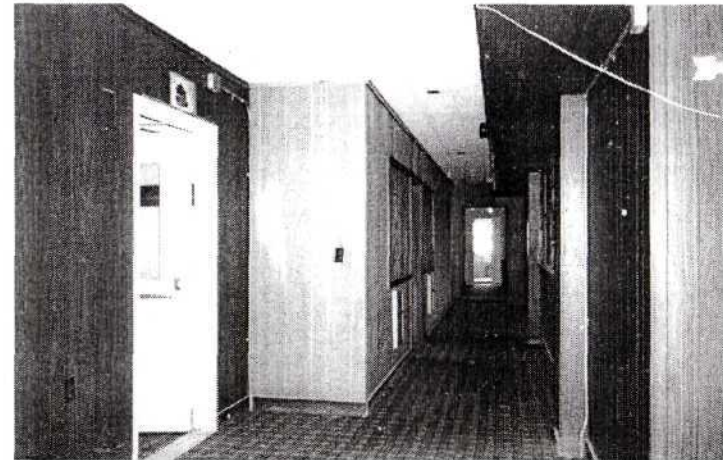
Interior corridor.

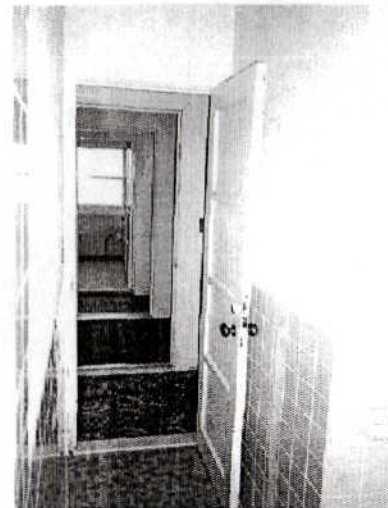
Interior – typical bathroom and hallway (beyond); note high thresholds.

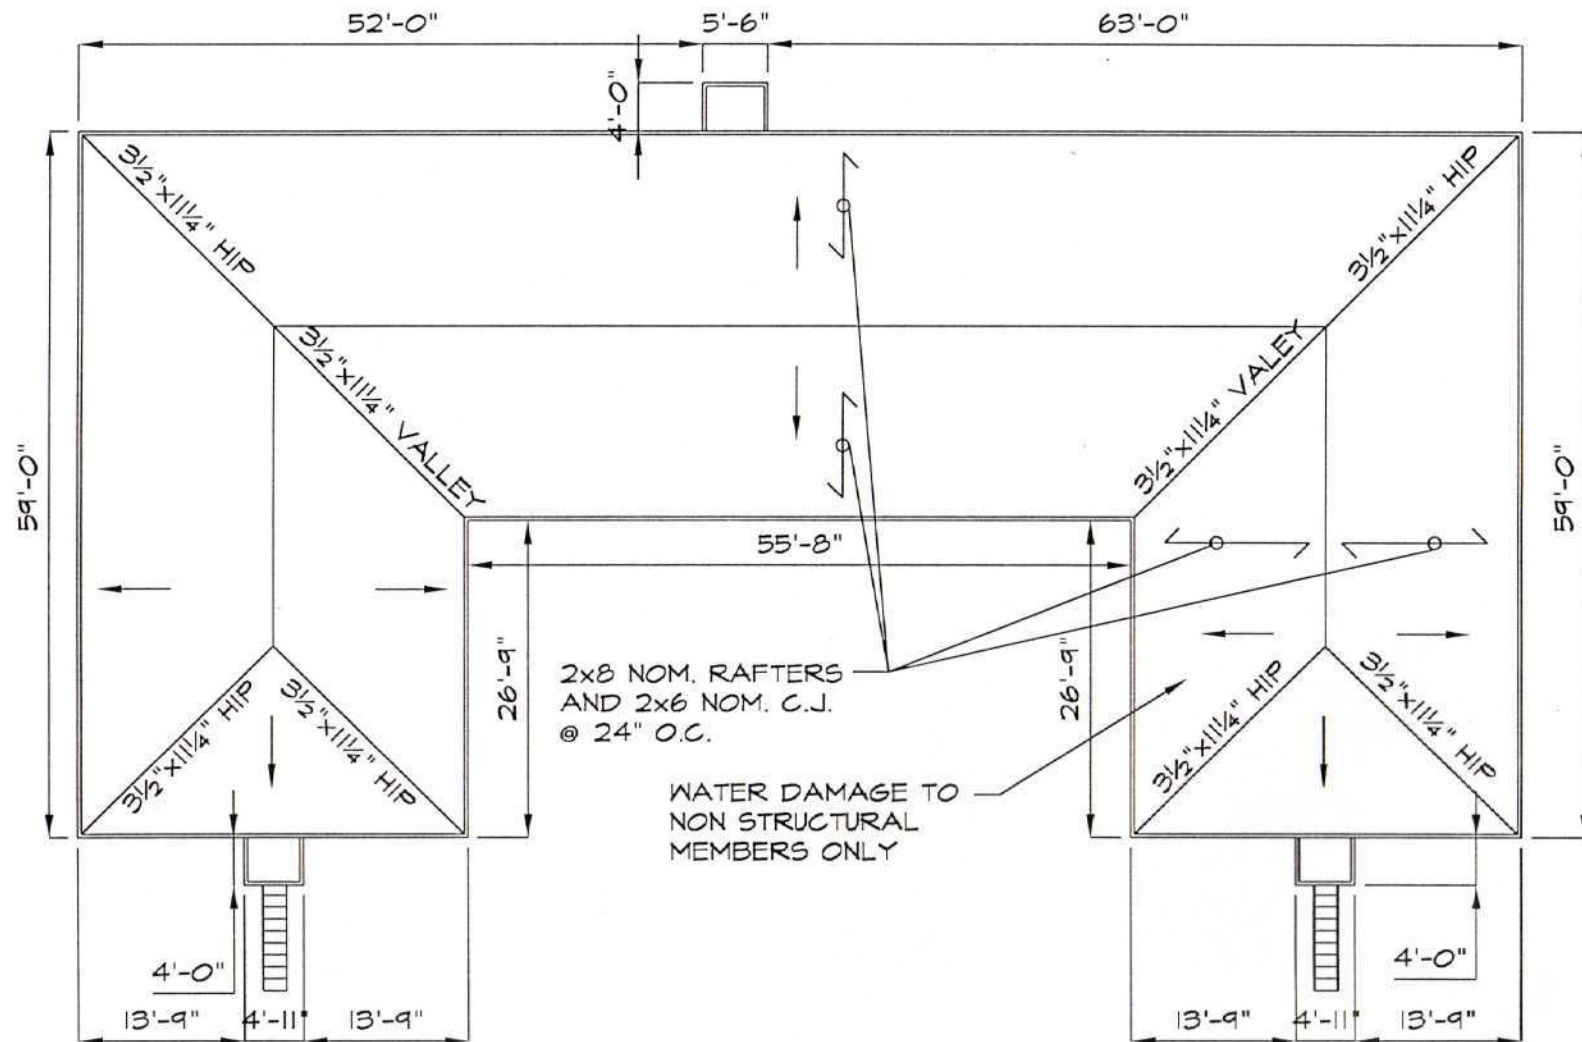
23 ROOF

- **Roof**
Asphalt shingle roof in **poor condition**. Advise replacement of all +/- 68 squares. Some deterioration at deep overhangs.
- **Wall**
Exterior is sheathed in white cedar shingles that have been weathered, especially on the South and East elevations. Overall **condition is fair**. Replacement of 800 SF recommended.
- **Trim**
Wood trim is in **fair condition**. Deep overhangs on two levels. Peeling paint everywhere. Recommend replacement of +/- 400 LF at eave/ corner, +/- 600 SF of soffits, and refinish all. 2nd floor sheet metal cladding in **fair condition**.
- **Foundation**
Concrete masonry unit (CMU) walls and crawl space in **good condition**. Leak at crawl space traps water in bulkhead. Poured concrete steps in **good condition**.
